# ANOTHER POINT TO CHECK ON OUR REAR SUSPENSIONS

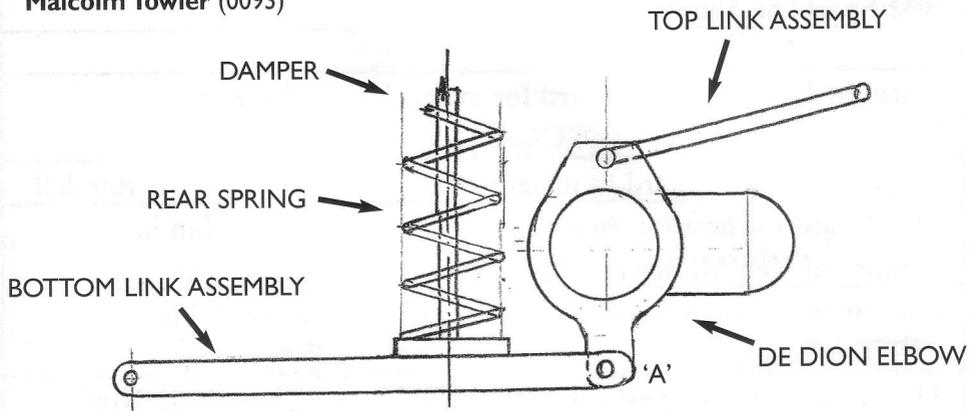
However, I recently experienced a different type of failure with the rear suspension, which, if it occurred at speed could have had very serious consequences. The problem concerns the bottom bolt to the De Dion elbow, with corrosion allowing the suspension bolt to become dislodged. As a result of this, the bottom link assembly becomes detached and is then forced down onto the ground by the rear spring.

I have sketched the area of the rear suspension showing the detail of the failure, which hopefully will assist members when checking their cars.

CORROSION HERE ALLOWS DE DION ASSEMBLY TO ROTATE BACKWARDS, RELEASING BOTTOM LINK ASSEMBLY, WHICH IS THEN FORCED DOWN BY THE REAR SPRING

Should corrosion be detected, it is comparatively easy to have strengthening plates/washers welded onto the elbow in the area of the bolt location hole, at least until a decision is made as to whether a new elbow is to be fitted.
