THAT CLUTCH SLAVE

P6 ROVER OWNERS CLUB

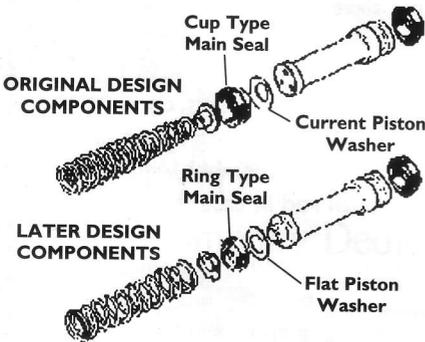
MASTER CYLINDER 15.8mm (5/8")

Master cylinders in the 15.8mm (5/8") size range have undergone certain design changes to the internal components and these are shown below

It pays when one watches what the original equipment manufacturers are doing. Somewhere along the line, Lockheed have modified their 5/8 inch bore master cylinders, which is the size used on the P6.

They have modified the design of the plunger to take a different type of cup. It can be observed that the modified plunger has features which increases its production cost when compared to the old one. Therefore the reason for the modification must have been to improve the reliability or performance, or both, of the unit.

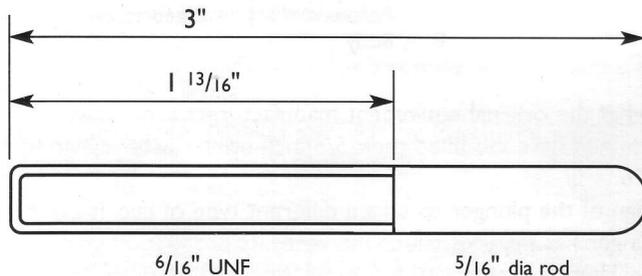
At one time, I played with the idea of boring out a slave cylinder and fit a stainless steel sleeve. But the cost of a new slave is not all that high and would not justify the cost of the machine shop operation. This is especially true when one notices that clutch fluid is corrosive, and other external parts of the linkage, over the years, corrode, for example, the push rod. I am at present toying with the idea of making a new push rod from a piece of stainless steel rod. For the convenience of any member who fancies taking up the idea, I give below the dimensions of the push rod in case the old one is badly corroded.
